**ELLIS ISLAND
STATUE OF LIBERTY NATIONAL MONUMENT**

**HISTORIC STRUCTURE REPORT
POWERHOUSE**

Volume 3

**Beyer Blinder Belle/
Anderson Notter Finegold**

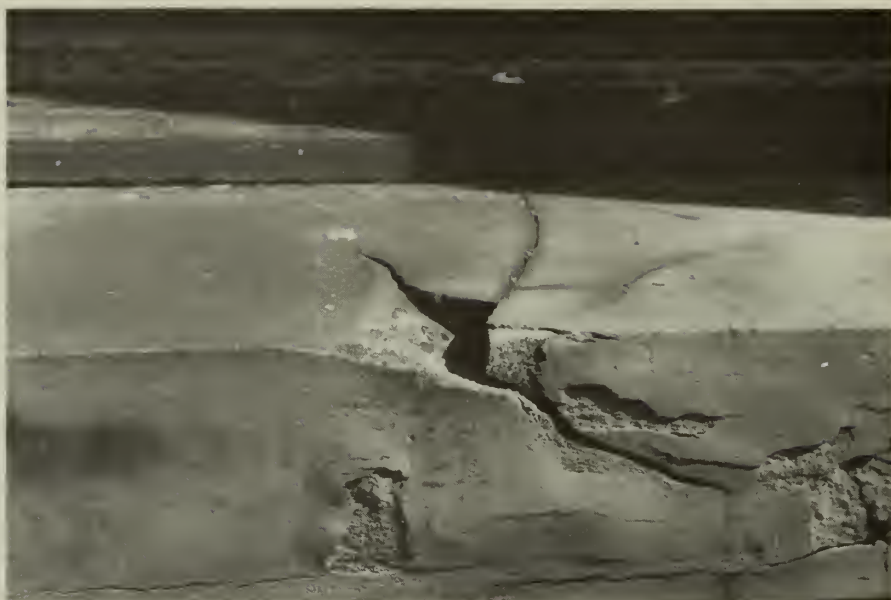
27. Cracking and spalling at window sill, east elevation.

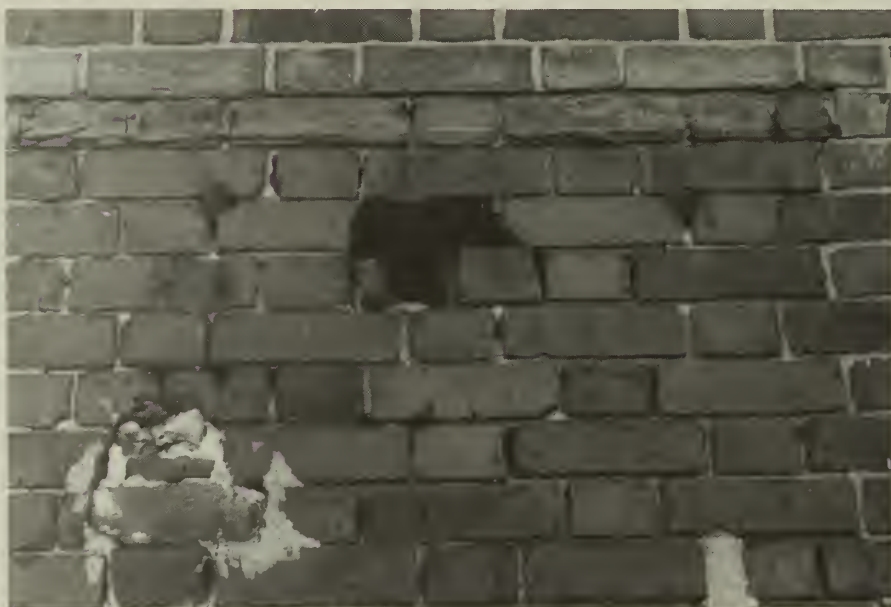
28. Loss of brick, deteriorating mortar, spalling, and patching, west elevation.

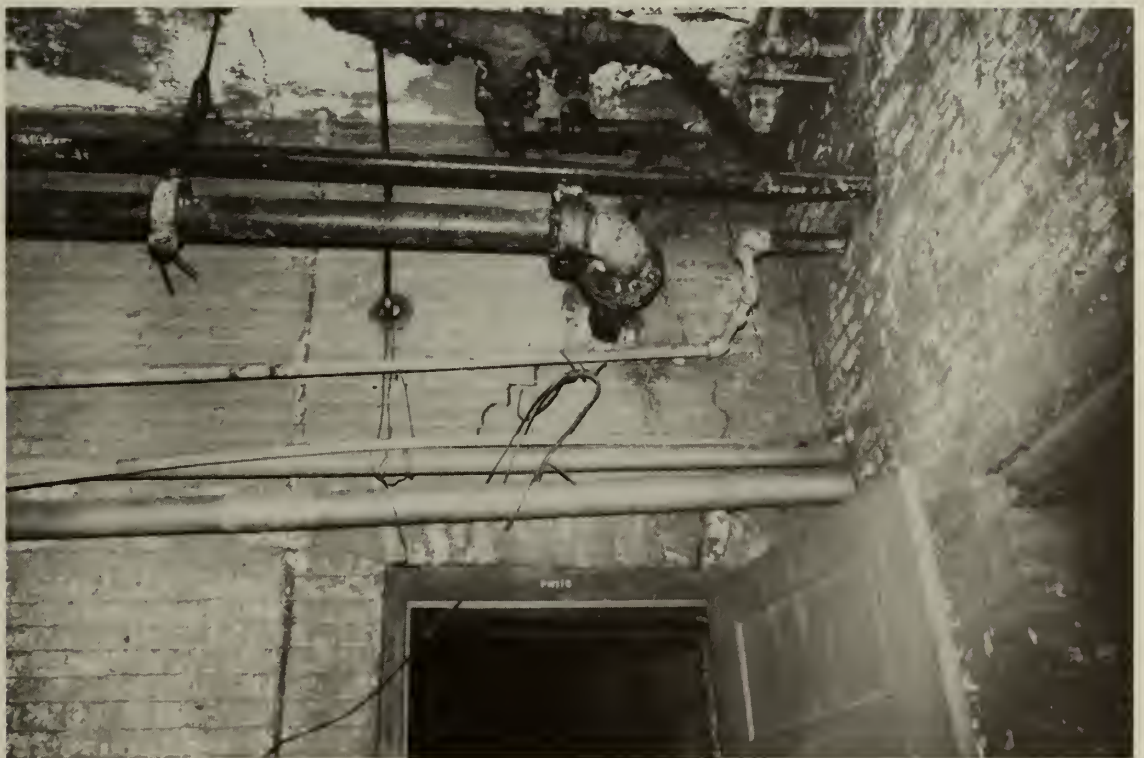
9. View showing cracking of interior bearing walls. As photograph 7
